“Habitat Assessment Survey Report”

GEO XYZ Offshore

N5a Development

| GEOxyz Report No. | LU0022H-553-RR-04 |

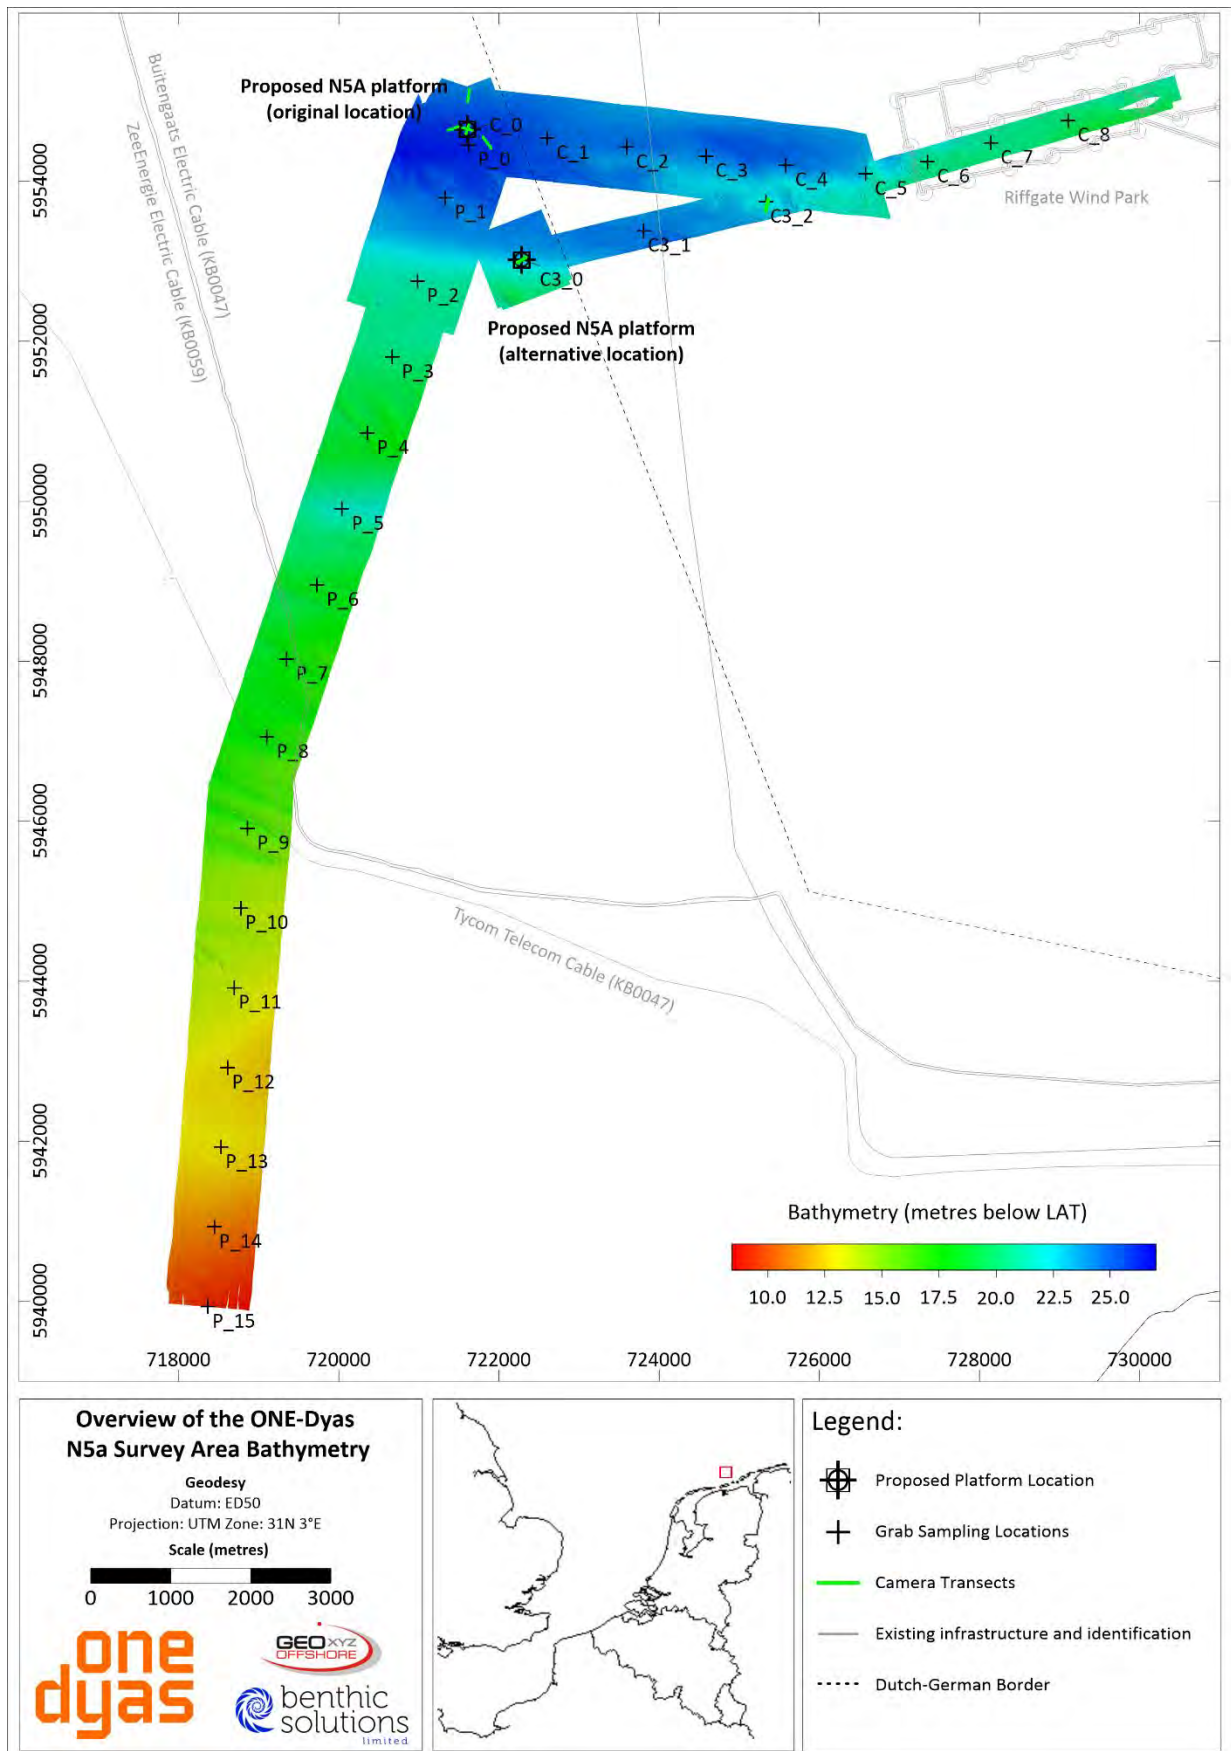
Figure 3: N5a Site and Route Survey Bathymetry

The seabed within the N5A site survey area sloped gently to the west. The minimum water depth was 23.7m LAT in the NNE of the survey area, while the maximum depth was 26.6m LAT in the WSW. Small areas with relief of up to 0.4m were observed on the bathymetry data with measured gradients of up to 6° on their flanks, which were interpreted to be largely due to outcropping clays.

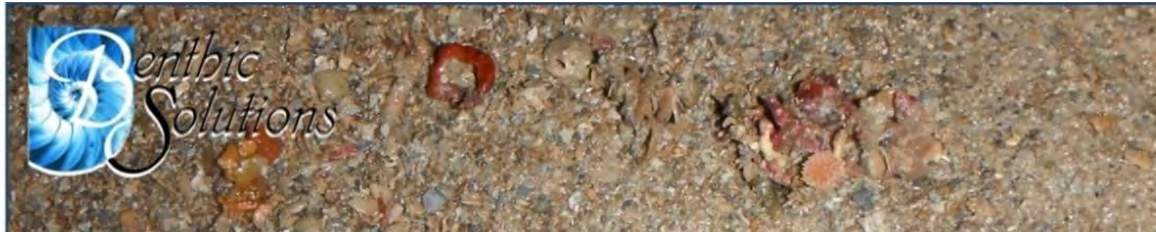
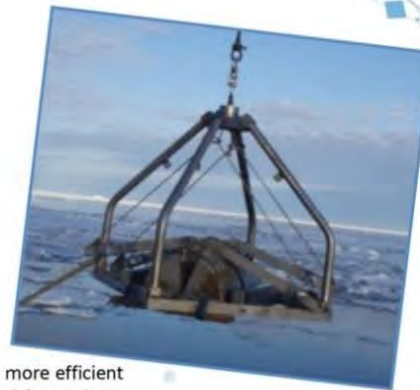
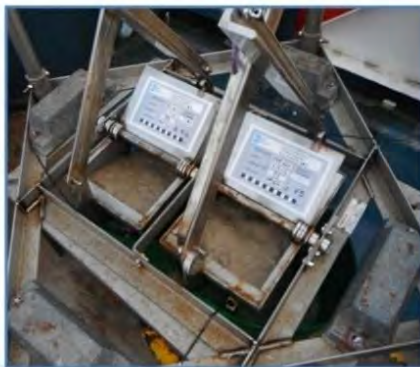
BSL DOUBLE GRAB

- 2 x 0.1m² Sample Area
- Total Stainless Steel Construction
- Adjustable weight
- Proven performance in 2000m depth
- Flat Pack for Air Freightting

The BSL Double Grab was designed and built by BSL in 2007 to carry out more efficient grab sampling operations in very deep waters. It is also routinely used for projects where multiple replicates are required or where both chemical and biological analysis are needed from the same deployment. This multi-purpose sampling tool is ideal for shallow water and deep water operations alike, halving the ship-time required to acquire sample replicates in moderate water depths.

Made of stainless steel, the grab can be ballasted with additional lead weights, for operations in deeper waters, strong currents or compacted sediments. The two pairs of extended stainless steel arms increase the leverage on closure to the buckets, but these can be fouled by coarser gravels.

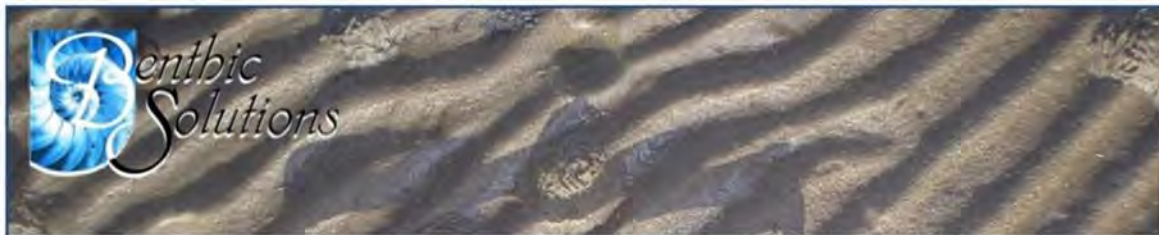
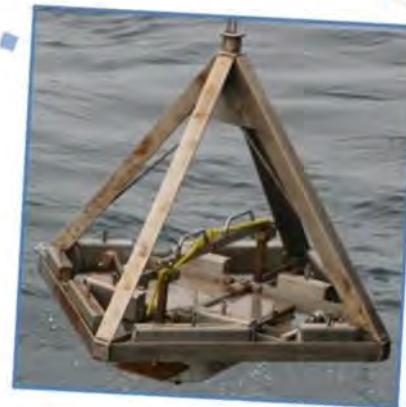
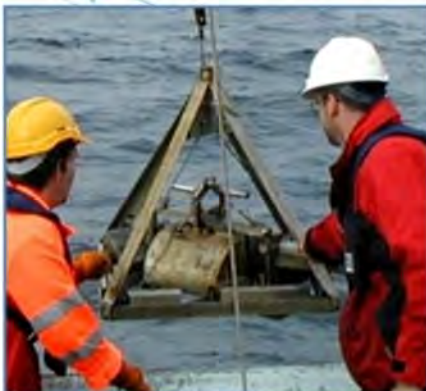
BSL MODIFIED DAY GRAB

- 0.1m² Sample Area
- Total Stainless Steel Construction
- Adjustable weight
- Compact Design
- Proven performance in 1000m depth
- Modified for One Man Operation

Day grabs comprise of two stainless bucket sections which are mounted within a stainless steel frame. On contact with the seabed, a trigger bar is pushed upwards via pressure plates allowing the buckets to close under the gravity of the unit through a pulley system. This controlled contact and closure once on the seabed helps ensure sample disturbance is minimised. The top of the grab is covered by two catch-closed inspection doors also made of stainless steel. The doors allow direct access to the sample inside the grab when closed, and protect the sample from the grab movement through the water column during recovery.

Our Day grab sampler (offset design) was originally modified by BSL's principle scientist in the early 1990s to improve penetration and reduce sample disturbance and contamination. These grabs are fitted with additional but removable stainless steel coated lead weights which can provide better penetration in more compacted substrates, but can also be removed to prevent over-penetration of the sampler in softer sediments.

A further extended bucket lip reduces sediment washout during retrieval. The unit can be supplied with a stand allowing for easy sample access and handling. A further modification that was made provided an efficient closure system to allow arming by a single person. This modified Day grab has become the standard operating tool for the North Sea.

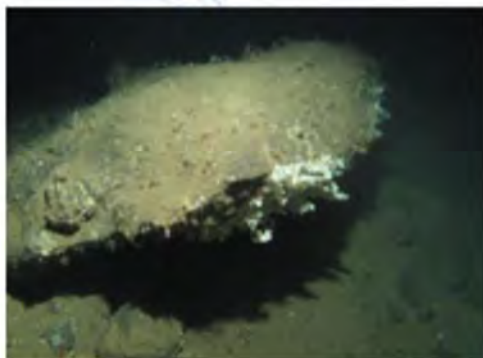
The system provides continuous targeting video data streamed to the surface where a computer is used to trigger the stills camera system remotely as required. These systems are fitted with inbuilt strobe units which can be deployed in a drop-down frame mounted configuration, or towed seabed sled (pictured). Seabed video is illuminated by 4 or 6 dedicated LED lamps with the camera orientated at an oblique or a downward looking aspect.

The system provides a very high quality digital image and is an ideal tool for ground truthing, habitat mapping and detailed seabed classification surveys from vessels in water depths in excess of 3km. Examples of previous projects include regional deep water surveys looking at iceberg keel scar, deep water coral and sponge communities and regional environmental habitat mapping assessments.

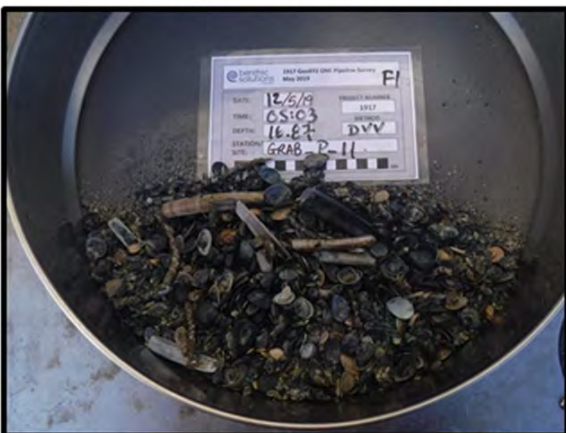
Sediment Example Image

Sediment Description
Coarse sand and rare shell debris with irregular ripples.

Conspicuous Fauna
Annelida: *Lanice conchilega* (Sand Mason). Arthropoda: Brachyura sp.

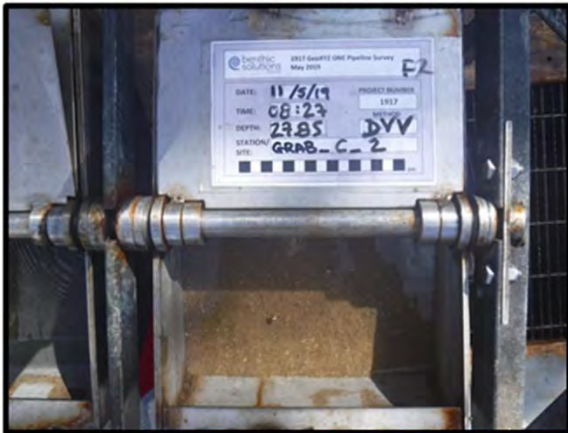
Sediment Example Image

Sediment Description
Coarse sand.

Conspicuous Fauna
Annelida: *Lanice conchilega* (Sand Mason). Arthropoda: *Liocarcinus* sp. Mollusca: *Loligo vulgaris*. Echinodermata: *Asterias rubens* (Common starfish).

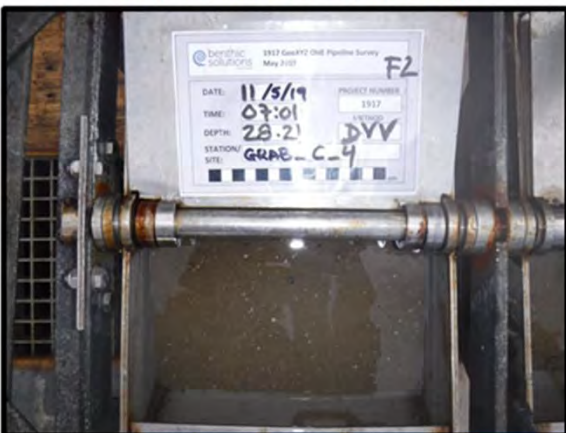
Sediment Example Image

Annelida: *Lanice conchilega* (Sand Mason). Arthropoda: Decapoda sp. Echinodermata: *Asterias rubens* (Common starfish).

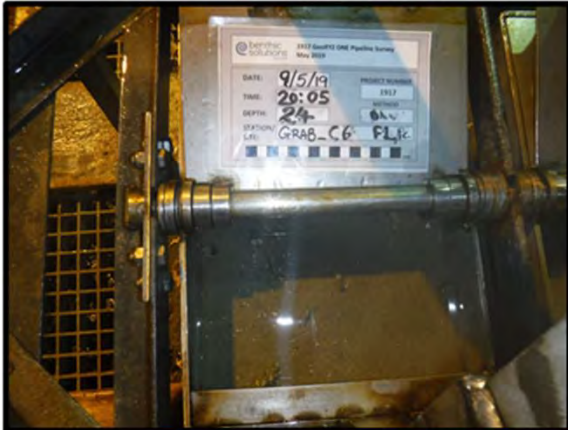
Sediment Example Image

Sediment Description
Coarse sand ripples with small shell fragments that have accumulated within each sand furrow.

Conspicuous Fauna
Annelida: *Lanice conchilega* (Sand Mason).
